## NAVAL AVIATION SAFETY CENTER

1. AIRCRAFT ACCIDENT BOARD APPOINTED BY	2. SERIAL NO	3. DTG (LOCAL) OF MISHAP	4. MODEL AIRCRAFT	5. BUREAU NUMBER
CO. VMO-5	1-57A	141245Z Apr 67	UH-1E	152437
6. TO Commander, Naval Aviation Safety Center	7. LOCATION OF MISHAP	8. TIME OF DAY	9. TIME IN FLIGHT	10. DAMAGE
VIA CO VMO-5	0680 RAD 10NM S1 Toro TACAN	NOON	0 + 26	ALPHA
CO MHTG-30	11. TYPE OF DAY	12. TIME IN FLIGHT	13. FLIGHT CODE	
CO 3dMAW	14. CLEARED FROM	15. TYPE CLEARANCE	16. AIRSPEED	17. A/C WEIGHT
CO ENRPAC	Coast Guard	VPR	60 kts E	7150
COMNAVSTA PAC	Station Pt. Vicente	18. ELEVATION AT TIME OF MISHAP	19. TERRAIN	(CRASH) 0
18. BRIEF DESCRIPTION OF MISHAP	20. LIST MODEL BUNO, REPORTING CUSTODIAN AND DAMAGE CLASSIFICATION OF ANY OTHER A/C INVOLVED	NONE		
Probable attempt at Forced Landing in Marginal Wx

VMO-5 AAR 1-67A, of 14 APRIL 1967, UH1E BUNO 152437, PILOT GREENLEESE  
"SPECIAL HANDLING REQUIRED IN ACCORDANCE WITH OPNAVINST 3750.6 SERIES"

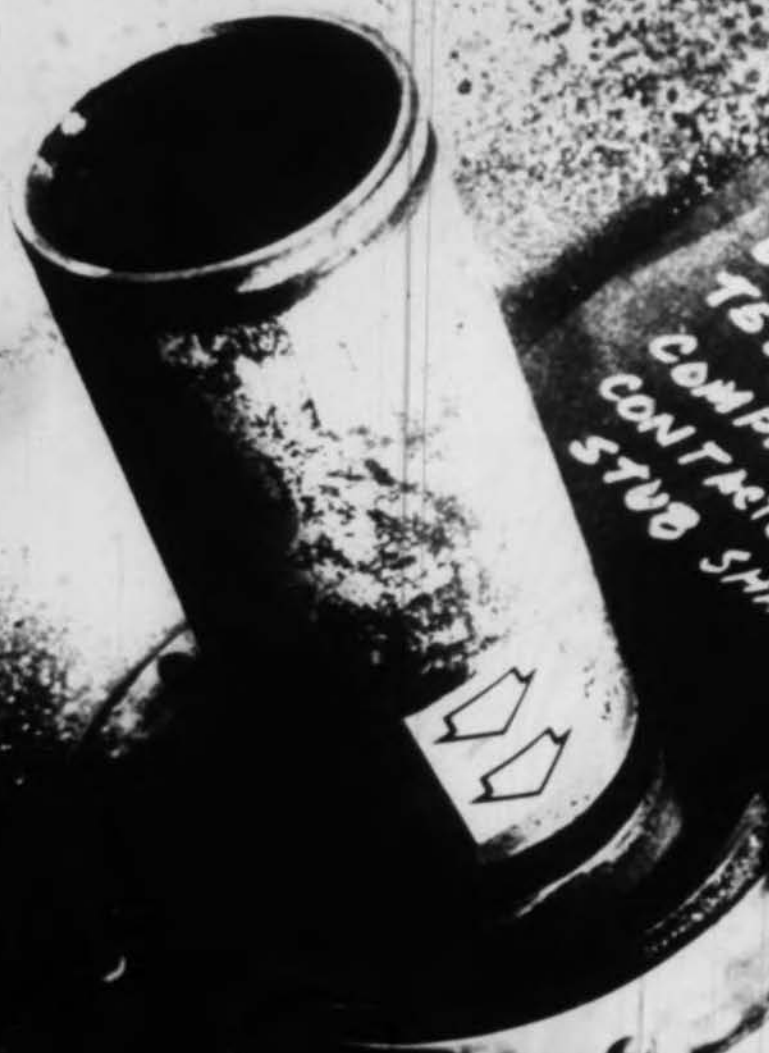
p. Buckling noted in the exhaust diffuser caused misalignment of the N2 turbine and caused the turbine stub shaft to contact the ID of the compressor shaft (Incl 17). The aft rim of the N1 turbine wheel also contacted the inner vane support on the N2 nozzle (Incl 18).

UH-1E A/C BuNo 152437  
T63-L11 ENG IN LEO9582  
COMPRESSOR SHAFT  
CONTACTED N2 TURBINE  
STUB SHAFT

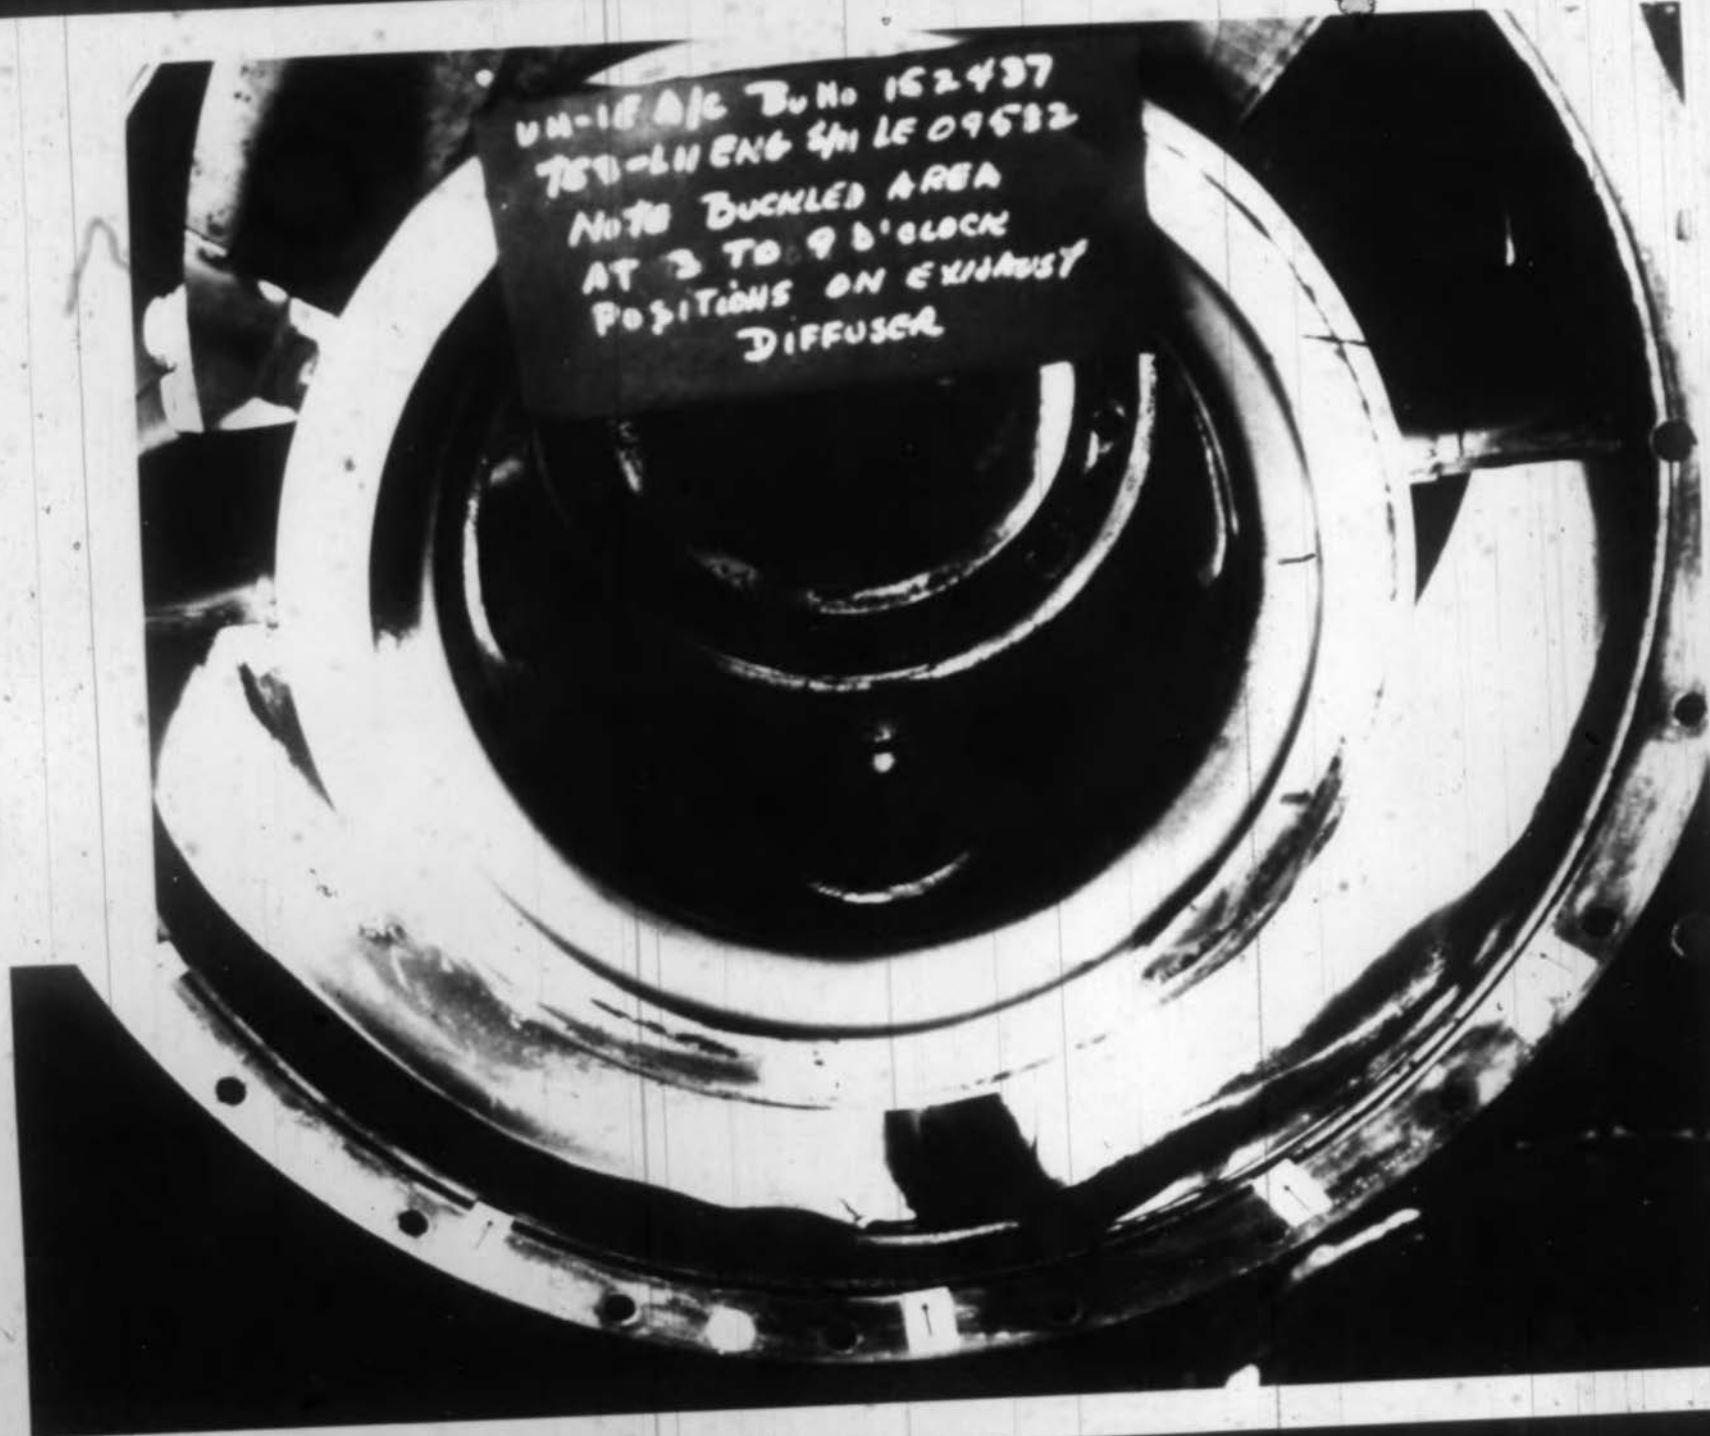
q. The buckled exhaust diffuser also caused the N2 turbine wheel forward rim face to contact the inner vane support (Incls 19 & 20).

UN-18 A/C Bu No 152437  
750-LH ENG 4M LE 09582  
NOTE BUCKLED AREA  
AT 3 TO 9 O'CLOCK  
POSITIONS ON EXHAUST  
DIFFUSER

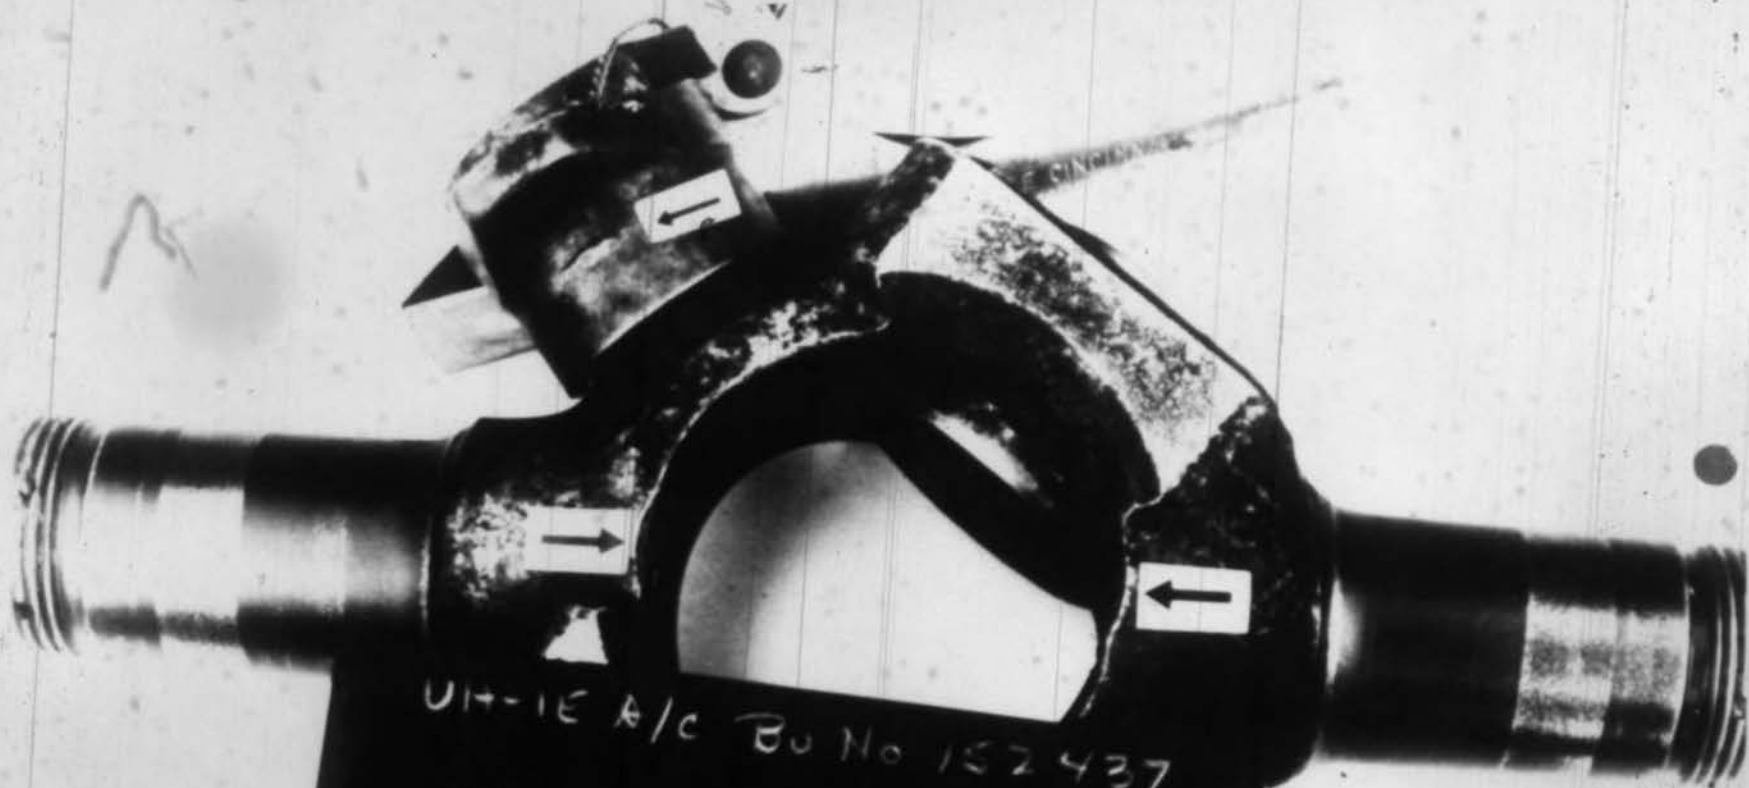
UH-1E A/C Bu No 152437

NOTE STRIKE MARKS  
MADE BY THE TAIL ROTOR  
YOKE ROUNDING ON THE  
STATIC STOP
